Terrestrial Standards and Studies, Report 89-1

WOOD PRESERVATIVE RESIDUES IN SOIL PRENDIVILLE WOOD PRESERVERS LTD., NEEPAWA, MANITOBA 1985

S.F. Phillips, D.L. Wotton and D.B. McEachern
Terrestrial Standards and Studies
Environmental Management Services Branch
Department of Environment and
Workplace Safety and Health

Report 89-1
February, 1989

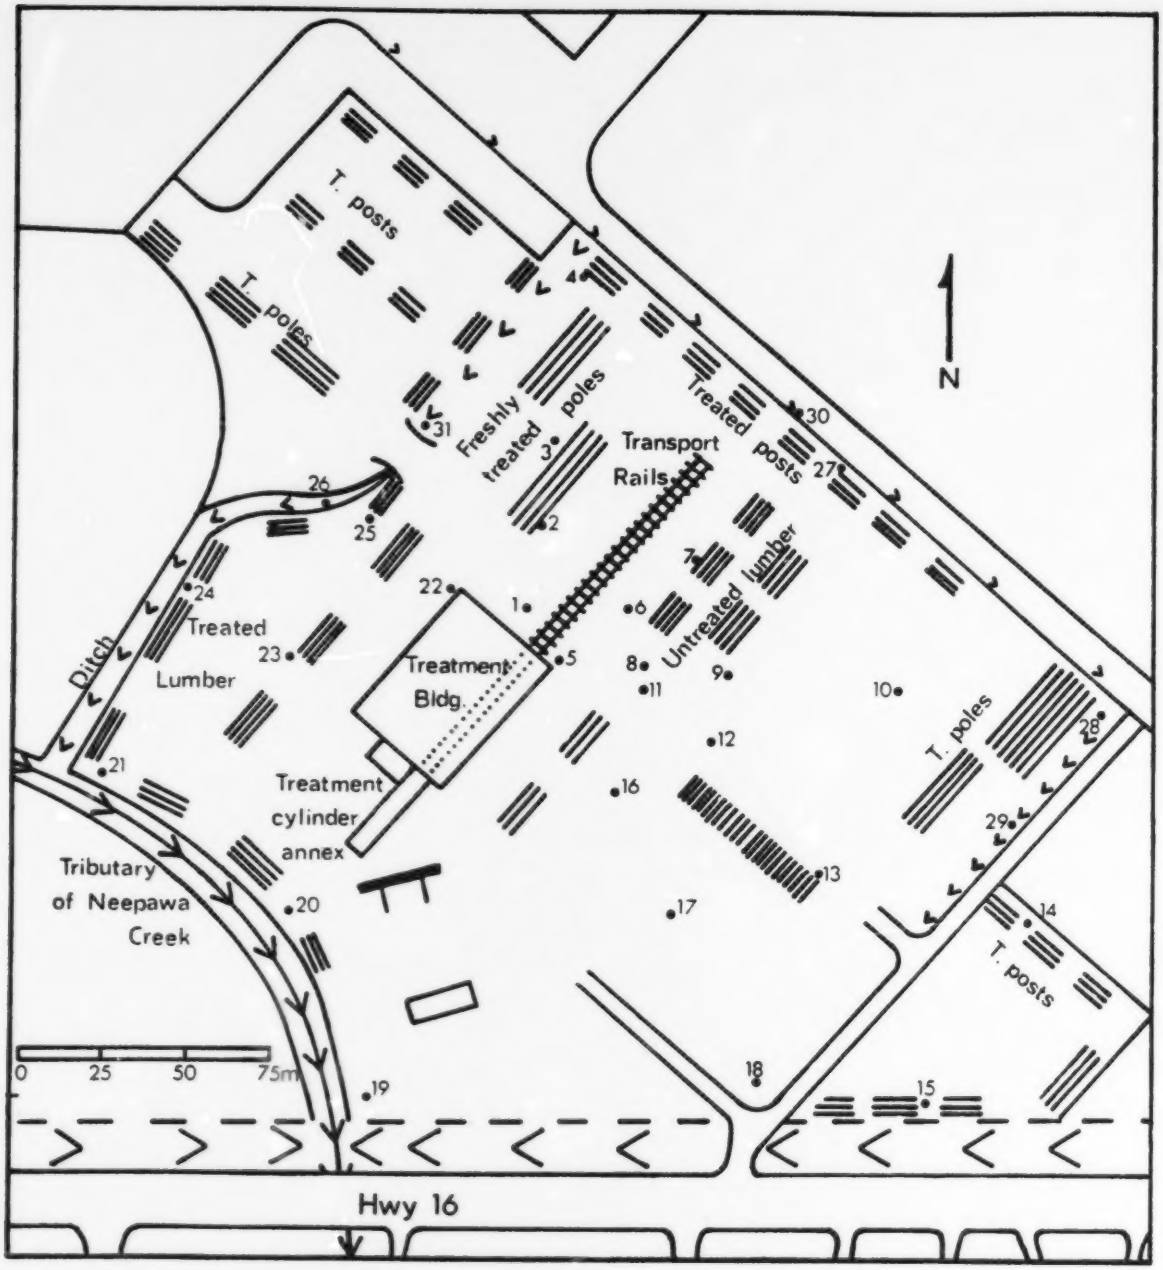
Fig. 1 : Site map of Prendiville Wood Preservers Ltd. Plant, Neepawa, Manitoba.

Thirty-one sampling locations were selected within Prendiville Wood Preservers Ltd. property (Figure 1) and a control was located 1.5 km north. Sites were located along 7 transects radiating from the main loading door of the treatment building. Within 60 m of the building, the sampling locations were spaced 25 m apart and beyond that the spacing was increased to 50 m. Some samples were taken from drainage ditches within the property and along its NE boundary.

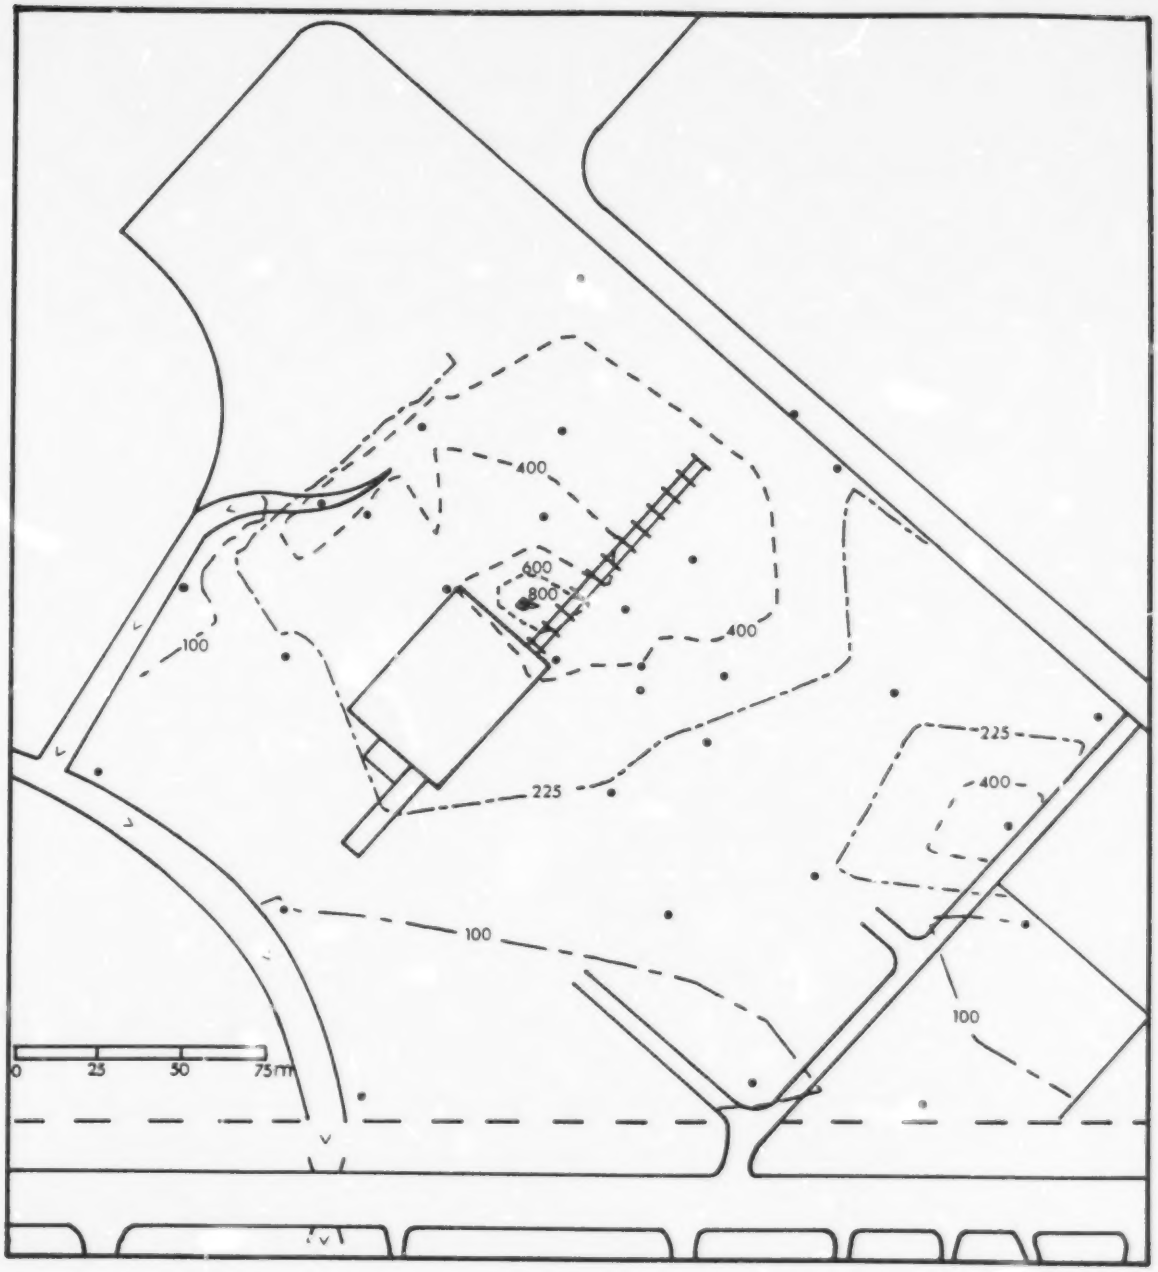
FIG.2: ISOPLETHS OF COPPER CONCENTRATION (µG/G) IN SURFACE SOIL AT PRENDVILLE WOOD PRESERVERS LTD., NEEPAWA, MANITOBA, 1985.

At the Prendiville site in Neepawa, Cu, Cr and As have accumulated in high concentrations in the yard NE, N and NW of the treatment building. The freshly treated wood is usually placed in that area immediately after being taken out of the treatment cylinder. The concentration was highest at site 1 which was close to the main door and also adjacent to the transport rails. The Cu concentration at site 1 was 865 µg/g while that of Cr and As were slightly lower at 653 µg/g and 641 µg/g respectively (Table 1). Although no sampling was done within the treatment building, concentrations were probably high there as well. The concentrations decreased with distance away from the transport rails and the main door into the treatment building. Concentrations of Cu, Cr and As in the surface soil were higher than at the control site (Cu:15 µg/g; Cr:10 µg/g; As:5 µg/g) indicating that there was some contamination over the entire Prendiville property. Although the

primary source of contamination was probably drips of preservative from freshly treated wood, yard maintenance such as grading or snow clearing could have moved some of the contaminated soil to other areas of the yard. Wind and water erosion are other agents which have no doubt moved contaminants to other locations.

There is also evidence that runoff water has transported preservative residues into ditches on the Prendiville property. Ditches along the SE and NE sides of the property as well as the one west of the treatment building have accumulated higher amounts of Cu, Cr and As than at adjacent sites on the property. This indicates that off-site movement via sediment transport has occurred. The western drainage ditch is of particular concern because it connects directly to the headwater of a tributary of Neepawa Creek. Sediments should be sampled from this tributary to determine if (or to what degree) it has been contaminated with Cu, Cr or As.

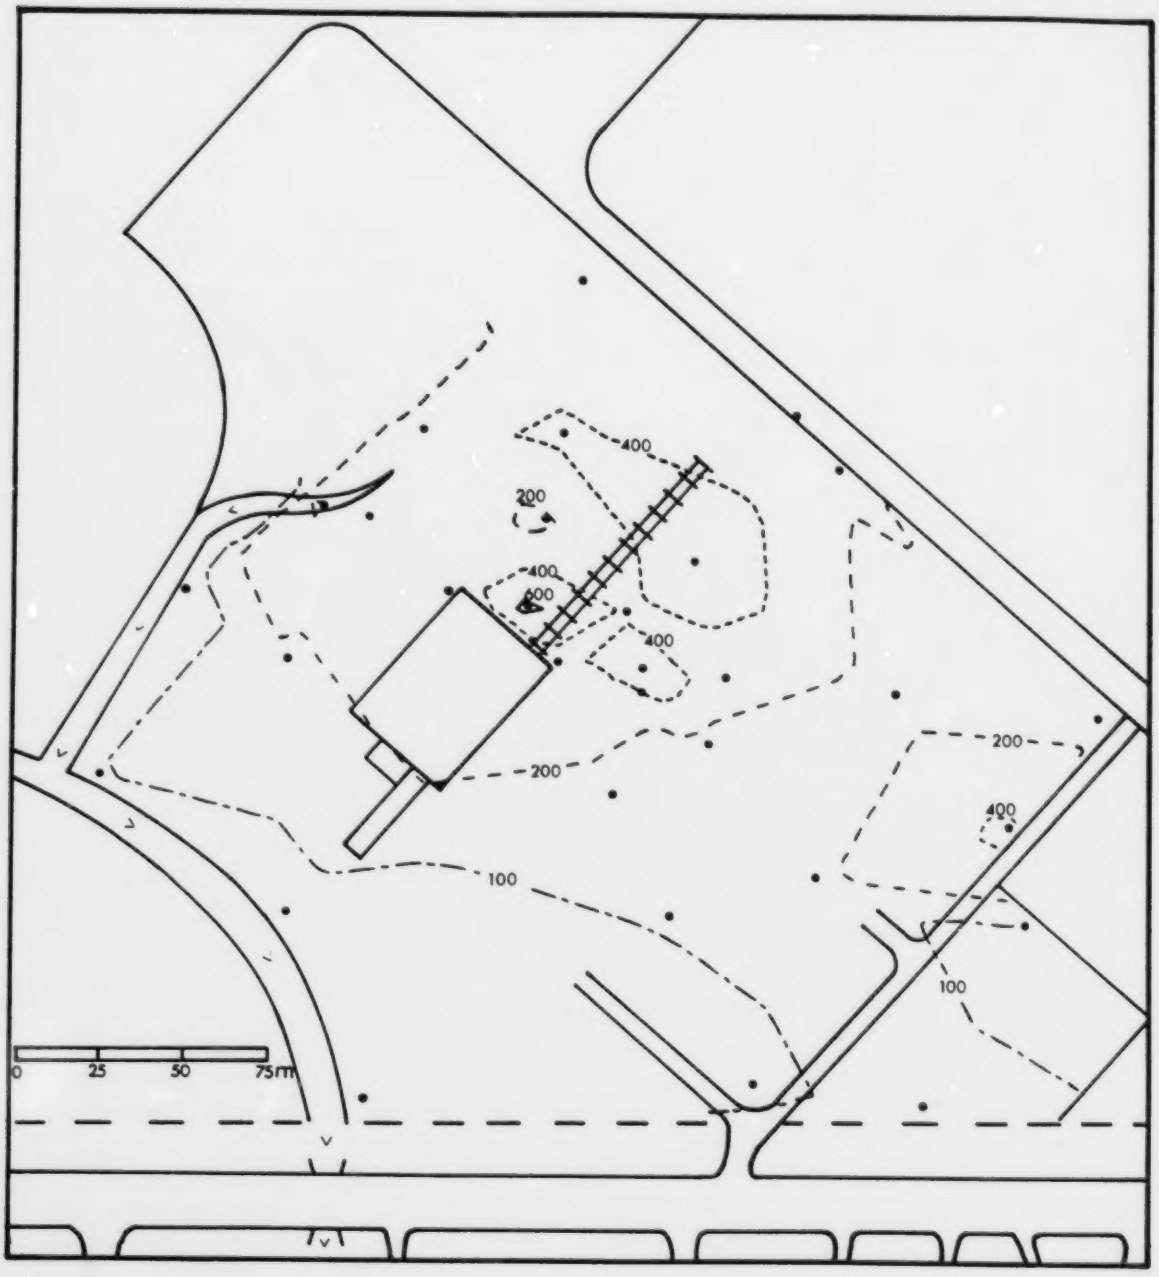
FIG.3: ISOPLETHS OF CHROMIUM CONCENTRATION (µG/G) IN SURFACE SOIL AT PRENDVILLE WOOD PRESERVERS LTD., NEEPAWA, MANITOBA, 1985.

higher than the limit, while the As limit was exceeded at 28 of 31 sites. Although the criterion for total Cr was not exceeded, a more serious environmental threat, Cr VI may have been overlooked. Dames and Moore (1984) found that in some soil samples, most of the total Cr was in the reduced Cr III form while in others as much as 50% or 100% was still in the Cr VI state. It is probable that elevated concentrations of Cr VI are present in soils of the Prendiville property. Because it is mobile (poor soil adsorption) as well as being highly phytotoxic, Cr VI has a very restrictive limit of 8 µg/g in sandy soils.

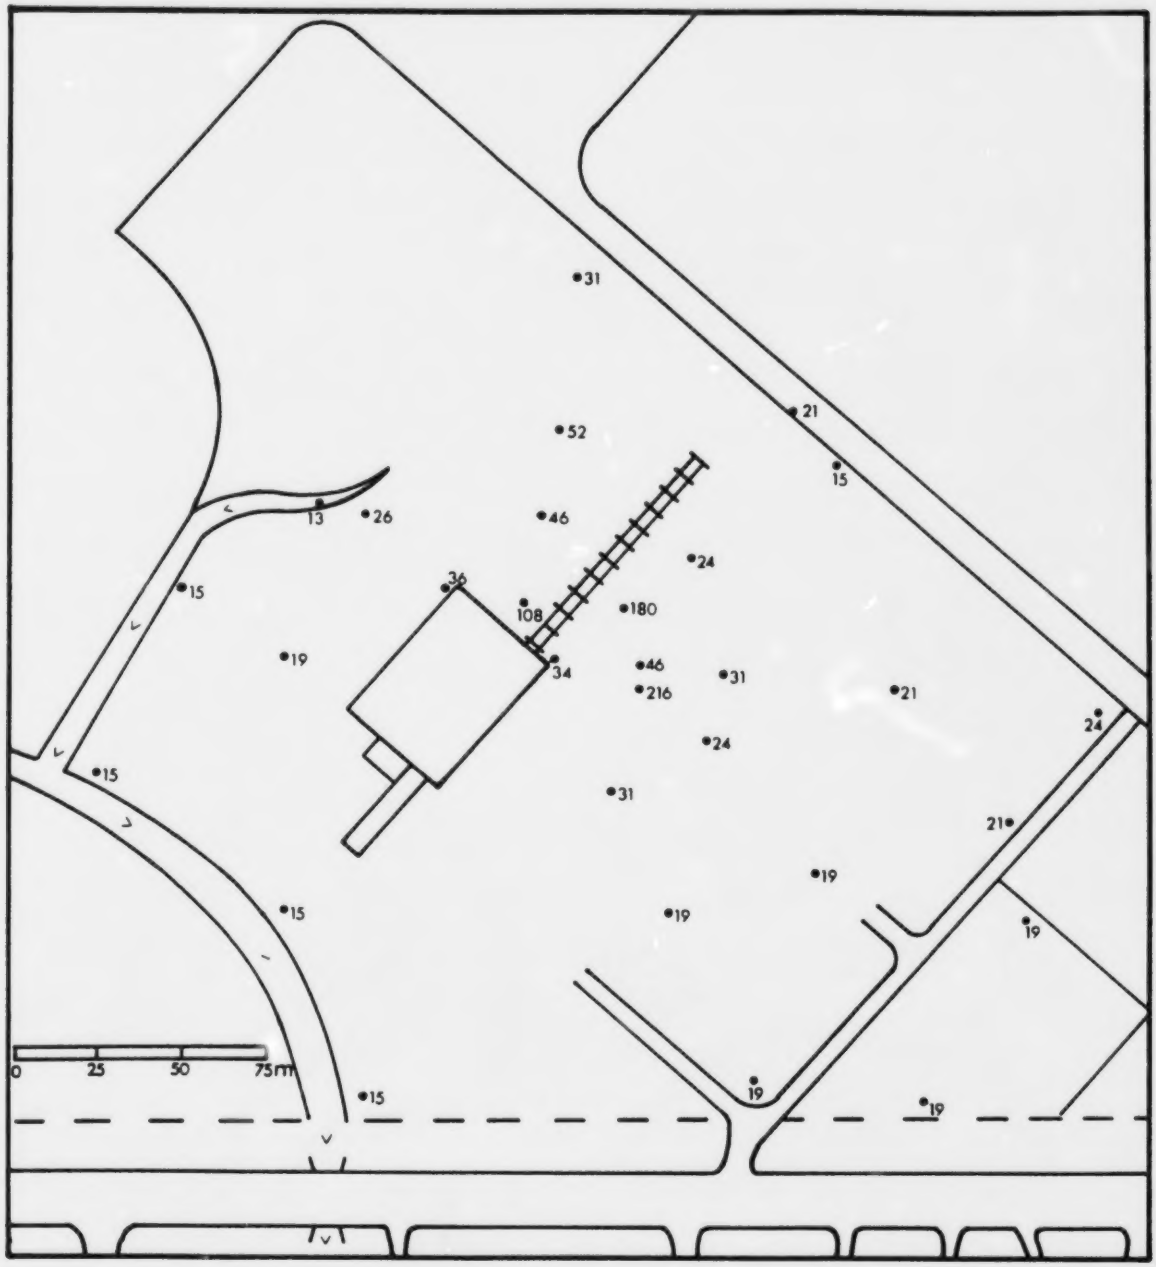
FIG.5: COPPER CONCENTRATION (UG/G) IN 5 TO 10 CM SOIL LAYER AT PRENDVILLE WOOD PRESERVERS LTD., NEEPAWA, MANITOBA, 1985.

Concentrations of Cu, Cr and As in the soil are much lower at the 5 to 10 cm depth (Figures 5, 6 and 7) which suggests that there is good adsorption potential in the surface soil which has limited downward leaching. There were three sample locations with high concentrations of copper in the 5 to 10 cm zone of the soil. These were sites 1, 6 and 11 at 108 µg/g, 180 µg/g and 216 µg/g respectively. Concentrations of Cr and As were also high in those three samples. Since sites 6 and 11 had lower surface concentrations than some of the other sites, the concentrations at the 5-10 cm depth were unexpectedly high. It is possible that those samples may have been inadvertently located where the yard was once rutted and subsequent yard grading has filled the ruts with the more highly contaminated surface soil.

Although subsurface soil testing has not been done on the property, Neepawa does have a high groundwater pollution hazard rating because of sand deposits close to the surface and also because of a generally shallow groundwater table (Mines, Resources & Environmental Management 1978). The log of a well drilled on the same section (31-14-15W) in 1983 recorded sand from the surface to a depth of 3.7 m (Natural Resources 1983). Many of the other wells drilled on adjacent sections had sand at or near the surface although some did have a layer of clay at the surface. A detailed soil survey of the Neepawa area (Manitoba Department of Municipal Affairs 1976) confirmed that the Prendiville Wood Preservers property has loamy textured surface soils (25 to 60 cm) underlain by sand to gravelly textured deposits. With these soil characteristics there is potential for downward leaching of wood preservative residues and the additional possibility that groundwater might be contaminated. The CCA wood treatment facility in California which caused Cr contamination of the groundwater (Cohen 1987) was also underlain by sand and gravel (Dames and Moore 1985). Detailed subsoil sampling should be carried out at the Prendiville property to determine if leaching is occurring.
